Crawford Station – Parcel O
Date: July 3, 2007

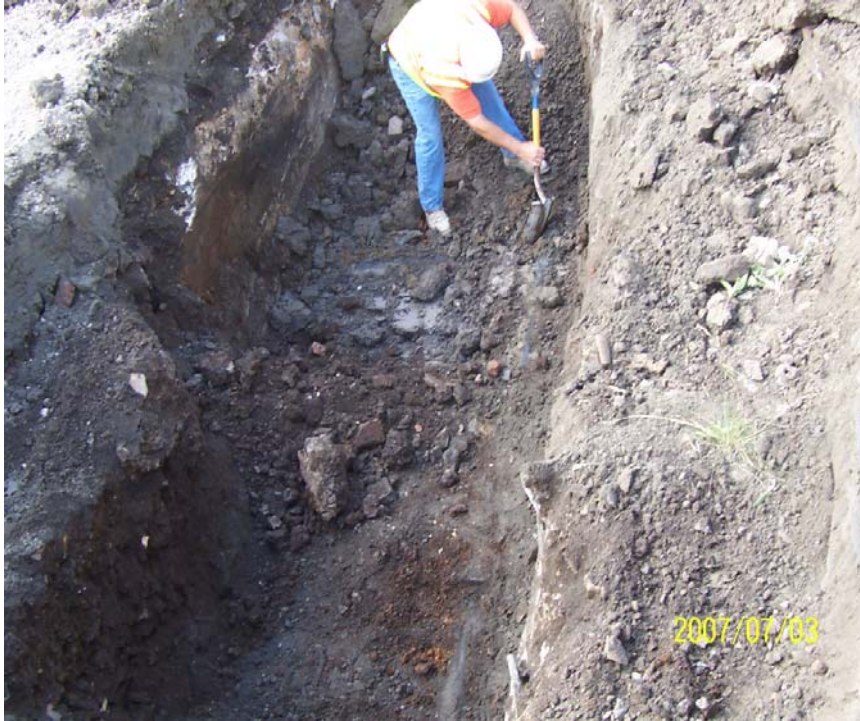
Description:
View looking south. Hand digging soil over an exposed 6-inch diameter pipe located west of the south purifier box.

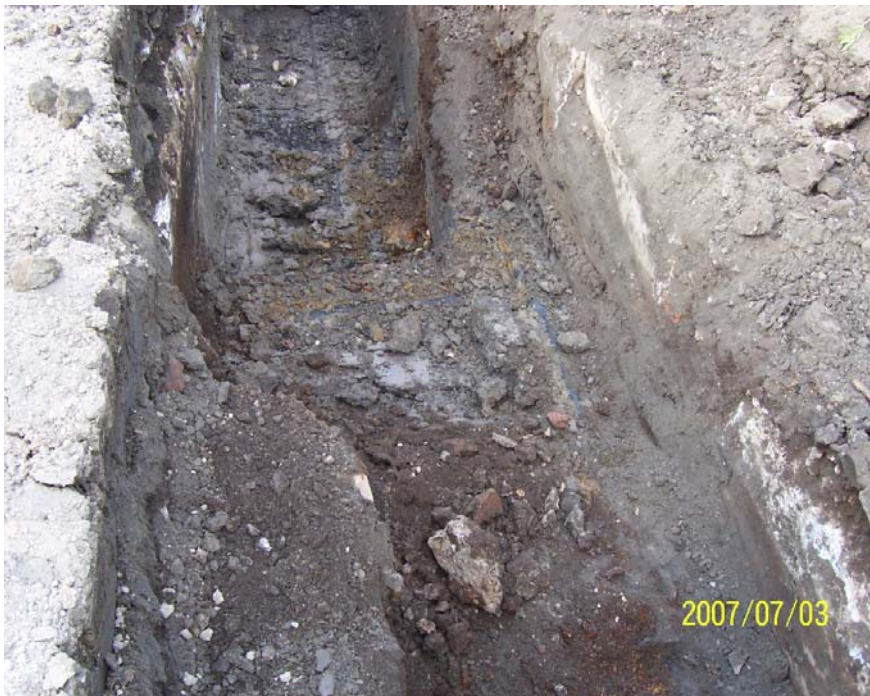
Crawford Station – Parcel O
Date: July 3, 2007

Description:
View looking south of two parallel concrete walls. The concrete wall on the left side of the photo is the western end of the south purifier box. The wall on the right is of an unknown structure.

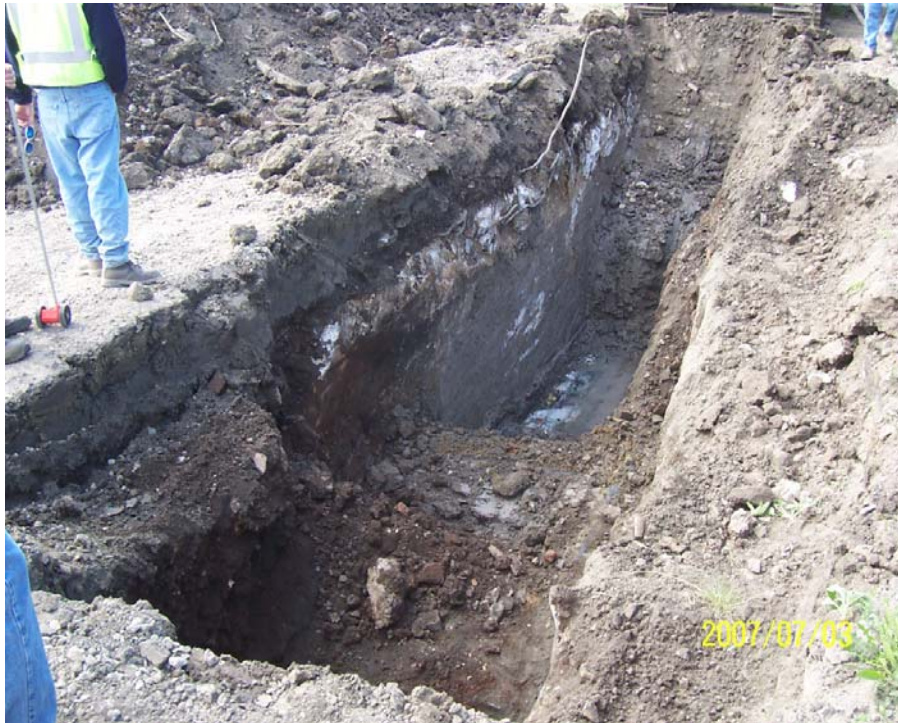
Crawford Station – Parcel O
Date: July 3, 2007

Description:
View to the south of the concrete footer used to support the western wall of the south purifier box. The top of the footer was located approximately 9 feet below ground surface.

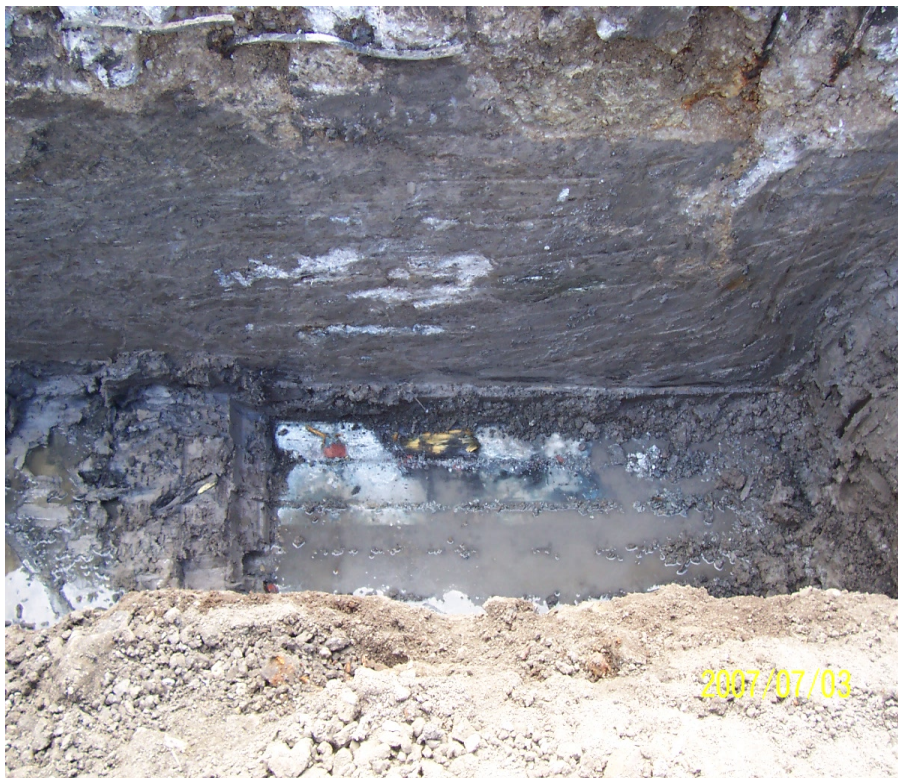
Crawford Station – Parcel O
Date: July 3, 2007

Description:
Exposed concrete footer west of the south purifier box. View looking east.

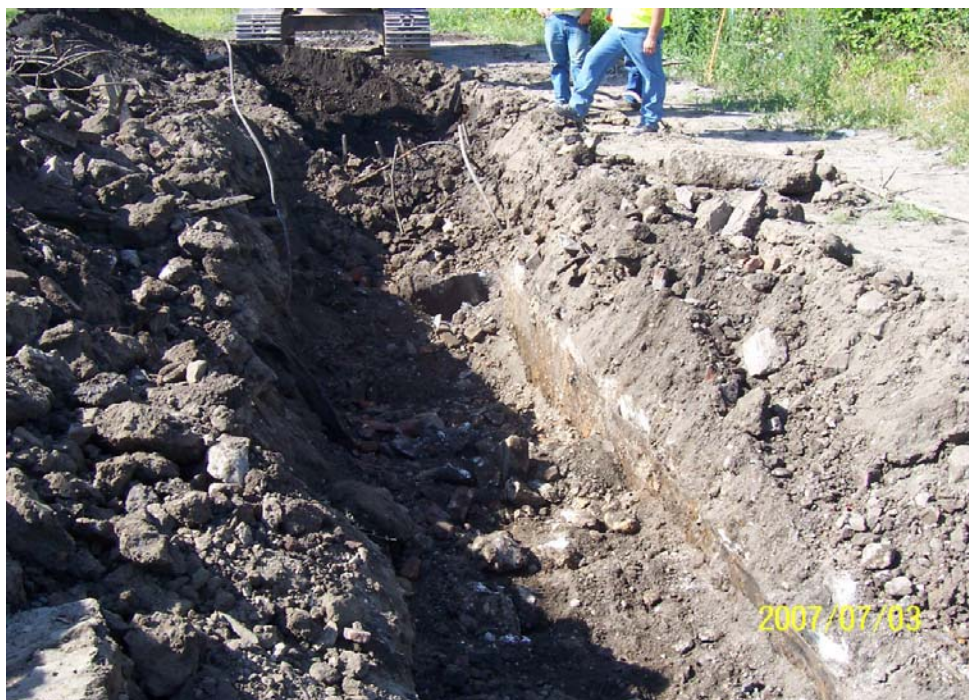
Crawford Station –
Parcel O
Date: July 3, 2007

Description:
Excavating inside
western end of south
purifier box. View
looking south.

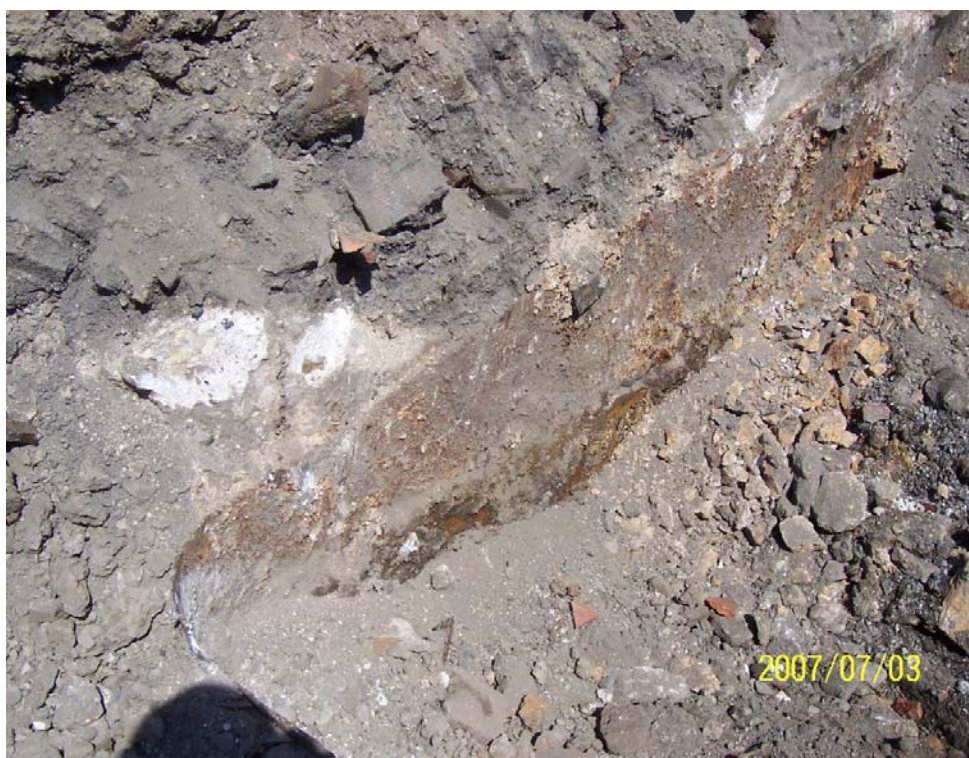
Crawford Station –
Parcel O
Date: July 3, 2007

Southwestern corner of
south purifier box looking
north. Inside wall of south
purifier box covered with
a steel plate.

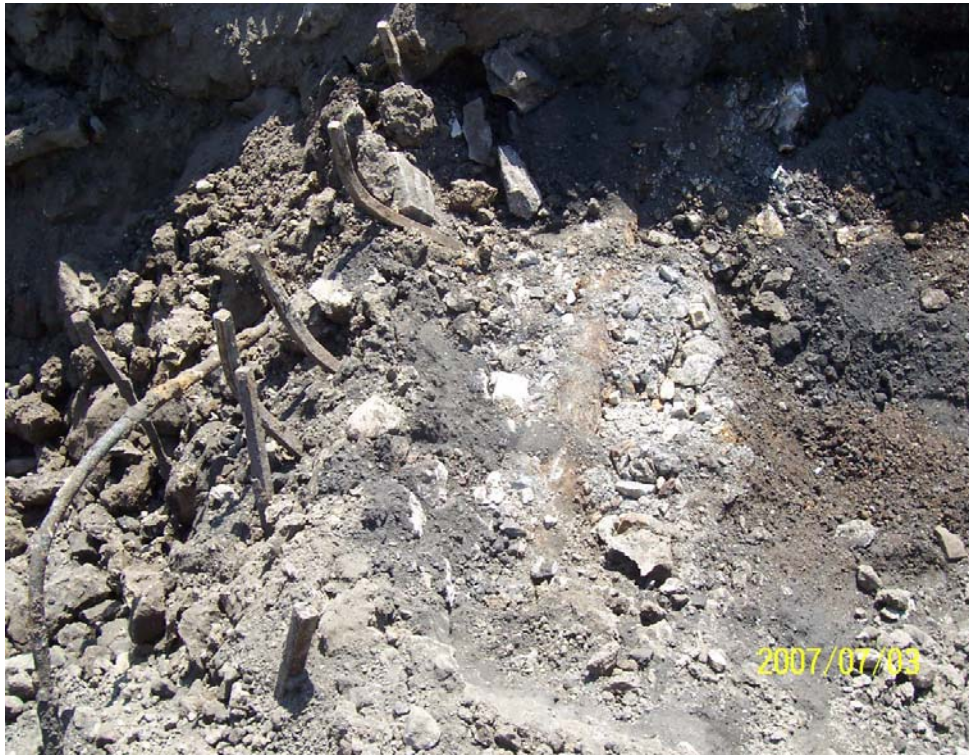
Crawford Station –
Parcel O
Date: July 3, 2007

Description:
Top of concrete wall
located approximately 7-
feet south of the southern
wall of the south purifier
box. View looking east.
This wall appears to
parallel the southern wall
of the south purifier box.

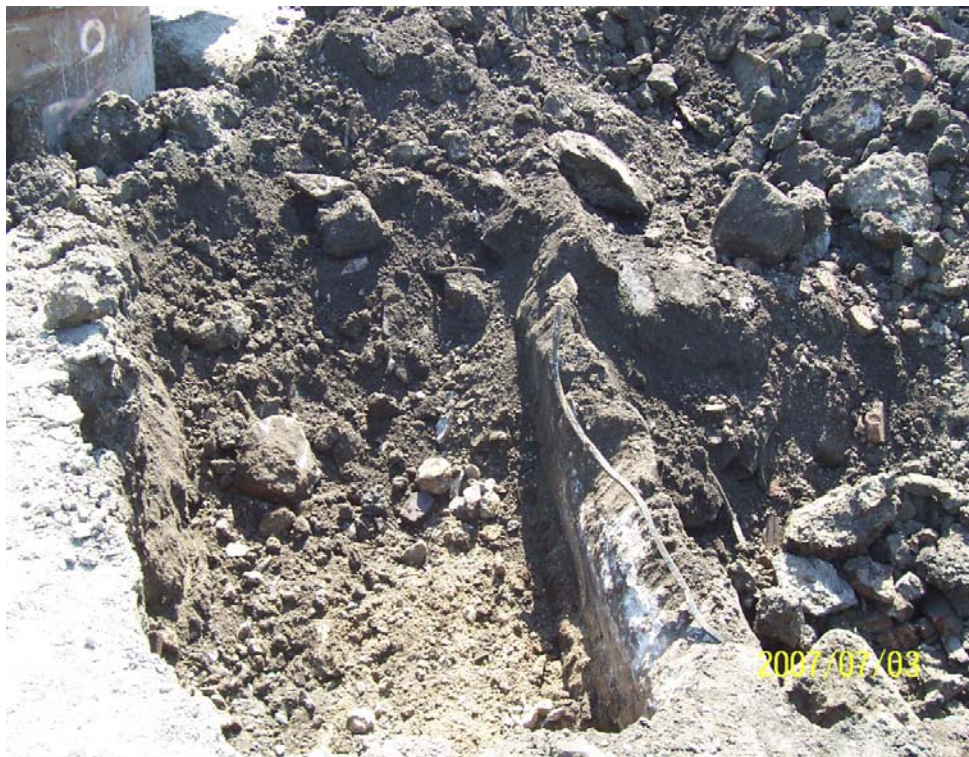
Crawford Station –
Parcel O
Date: July 3, 2007

Description:
Southwestern corner of the
north purifier box. View
looking east.

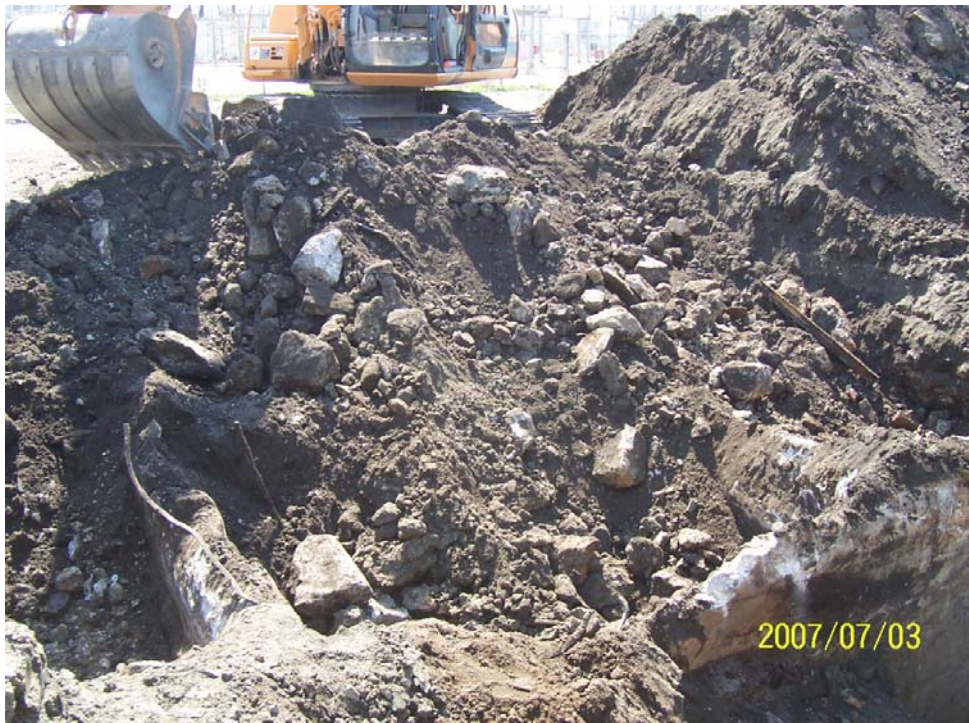
Crawford Station –
Parcel O
Date: July 3, 2007

Description:
View to the east of the
north and south purifier
boxes. A concrete wall
connecting the western
ends of the boxes is visible
in the lower right corner of
the photo.

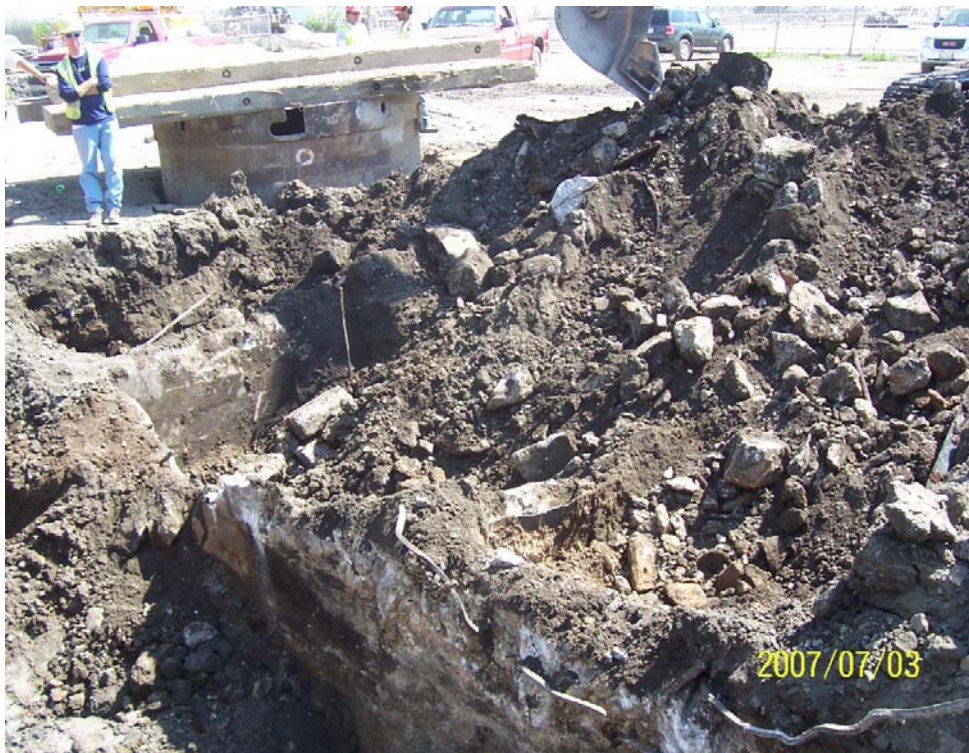
Crawford Station –
Parcel O
Date: July 3, 2007

Description:
Western ends of the
purifier boxes looking
northeast. Auger used to
drill the ComEd tower
foundation is visible in
upper portion of the photo.

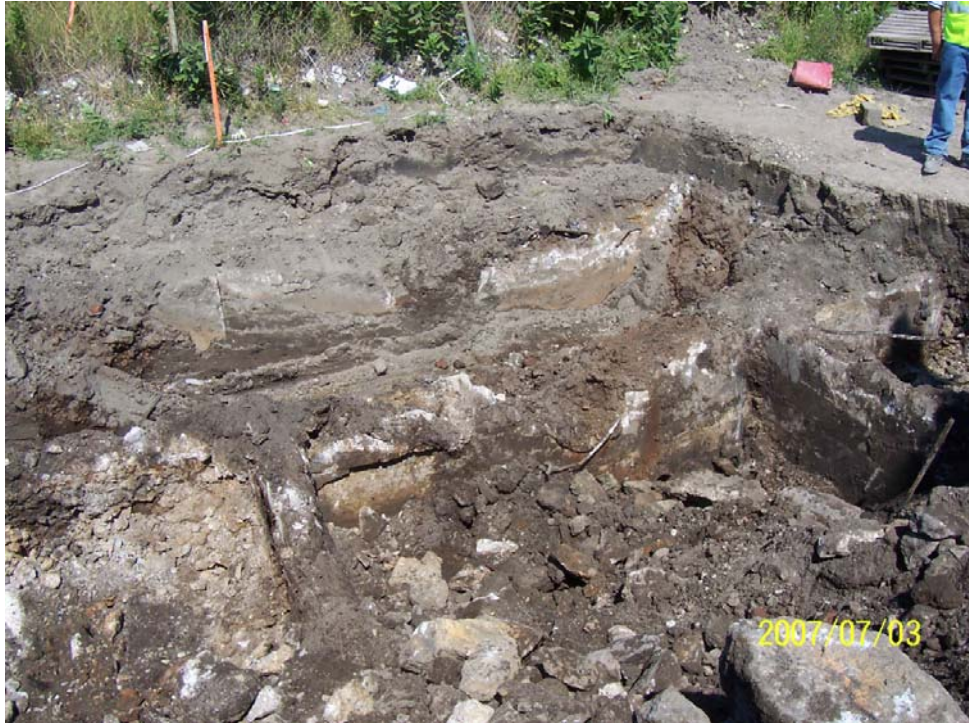
Crawford Station –
Parcel O
Date: July 3, 2007

Description:
Western ends of the
purifier boxes looking to
the west. The concrete
wall connecting the
purifier boxes is located in
the center of the photo.

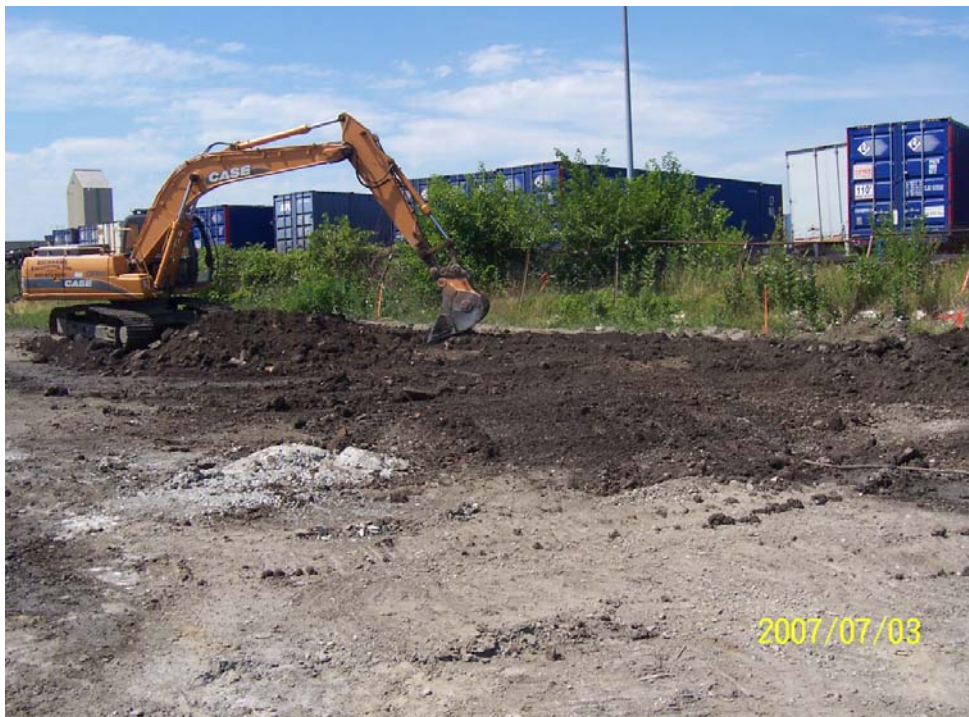
Crawford Station –
Parcel O
Date: July 3, 2007

Description:
Backfilling excavation
looking southwest.
